CONTAMINATION OVERVIEW STUDY
FIRST AVENUE & MCNAUGHTON AVENUE, OSHAWA, ONTARIO

10-13170

JUNE 12, 2024

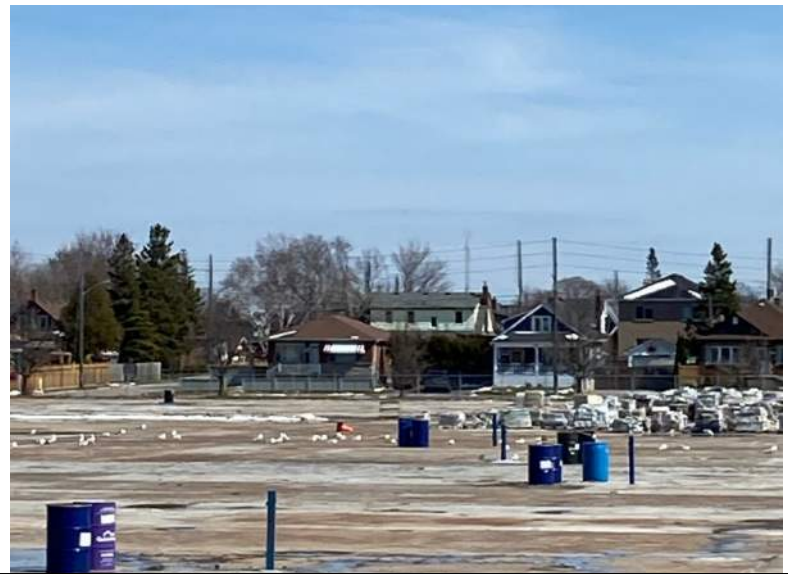
Photograph 2:

View looking west across the northern portion of 155 First Avenue. Former PPG Canada / Duplate glass manufacturing. Newly installed wells visible, plastic and steel drums, and stored building materials on pallets.

- Former glass and fibreglass product manufacturing facility with previous use as an Iron Foundry, and with historical underground fuel storage tanks, coal storage, solvent storage, and P.C.B. waste storage at 155 First Avenue (P.C.A. #4).

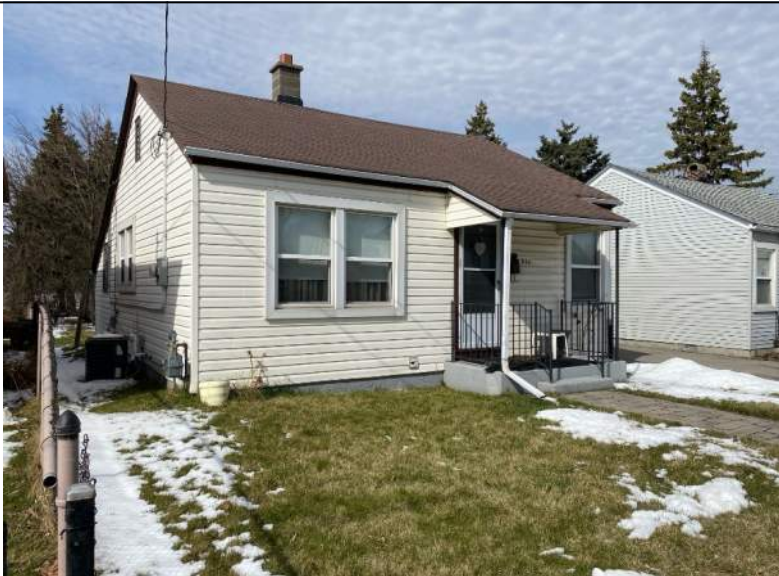
Photograph 3:

516 Drew Street, location within the Site of a 300 L spill of furnace oil in 1997.

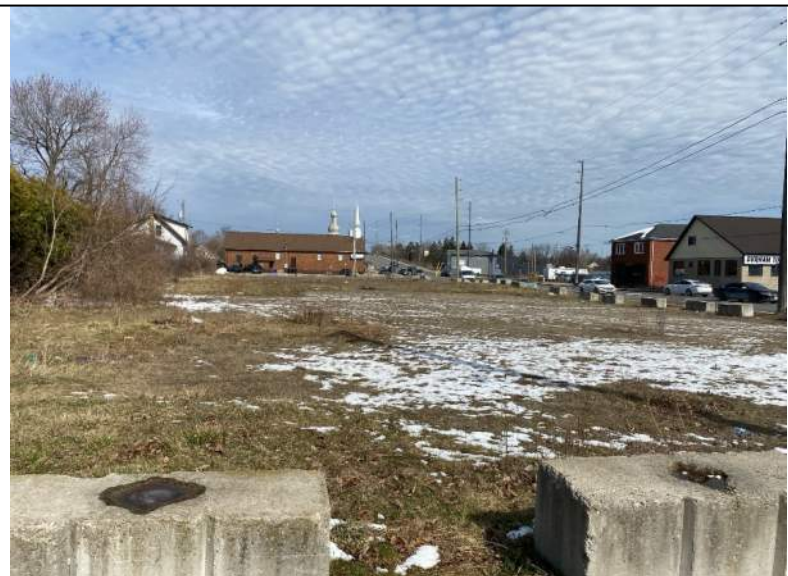
Photograph 4:

View looking north at 506 Ritson Road S., former Esso gas station within Site.

- Former fuel service station at 506 Ritson Road S. with confirmed exceedances of the Table 3 residential site condition standards for P.H.C. F1 and F2, P.A.H.s, and inorganics in soil, and P.H.C. F2 in groundwater reported in a 2014 Phase II E.S.A. report. Spill event of approximately 10 L of furnace oil to the ground at 506 Ritson Road South (P.C.A. #7).

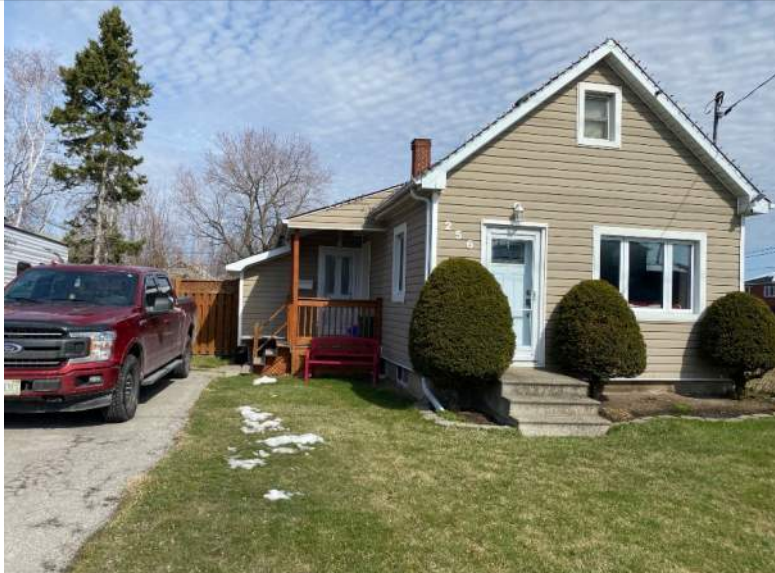
Photograph 5:

256 McNaughton Avenue, location of waste oil spill migrated from adjacent 506 Ritson Road S. in 1994.

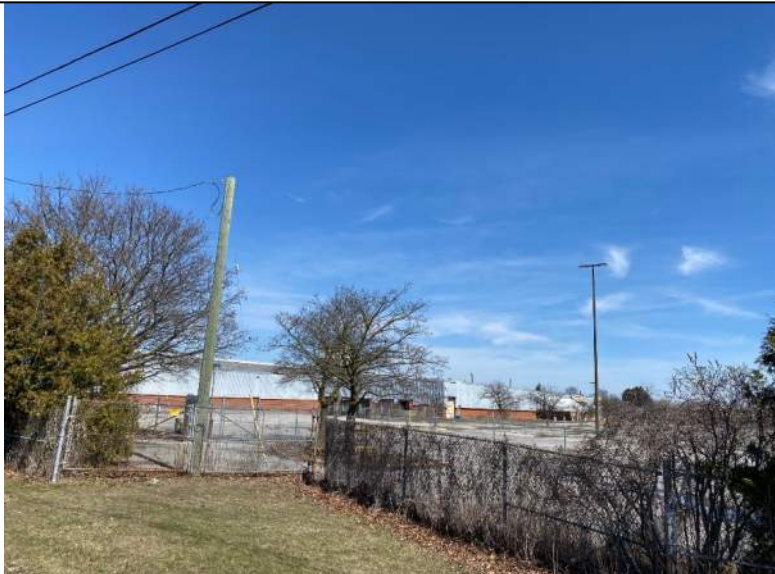
Photograph 7:

View looking north at 500 Howard Street, former Ontario Malleable Iron Co. factory, PCB waste generation by Metrolinx, photo processing wastes by Speedy Photo.

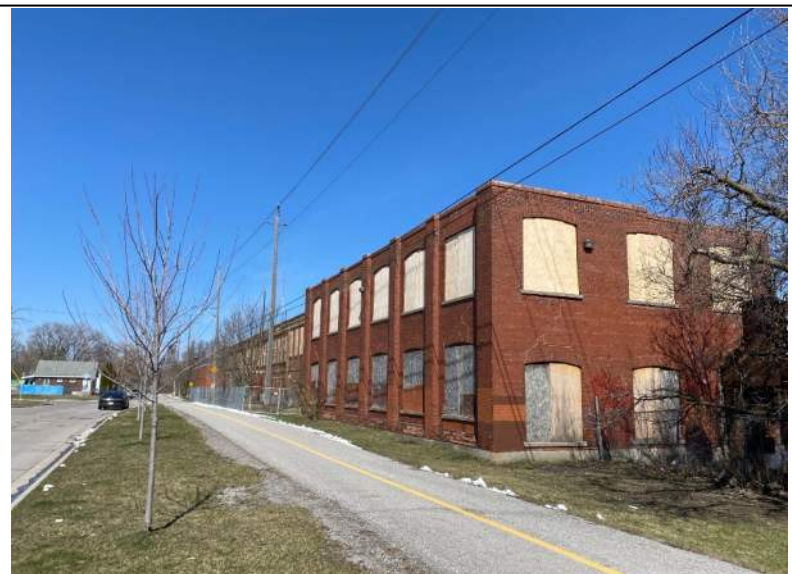
Photograph 8:

View looking north at 500 Howard Street near Albany Street, former Ontario Malleable Iron Co. factory, PCB waste generation by Metrolinx, photo processing wastes by Speedy Photo.

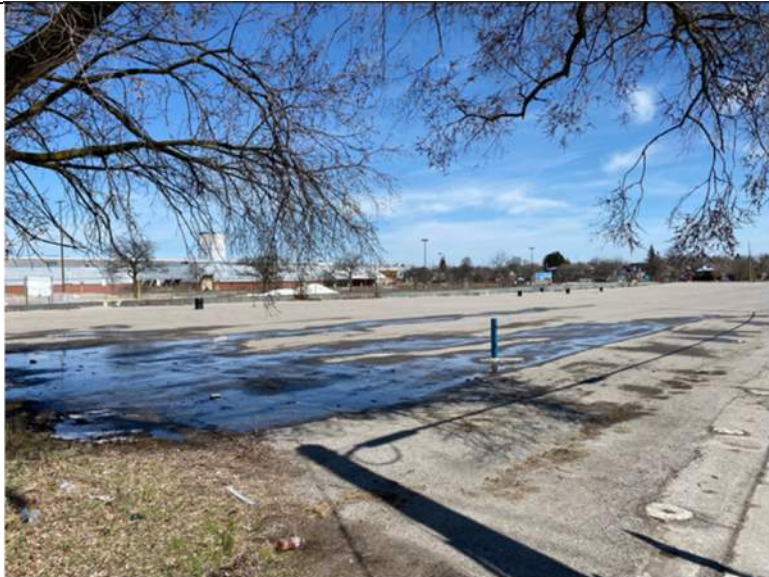
Photograph 9:
View looking northeast at 144 First Avenue . Newly installed wells and steel drums visible. Former glass manufacturing and metal foundry uses, used as parking area since at least 1954.

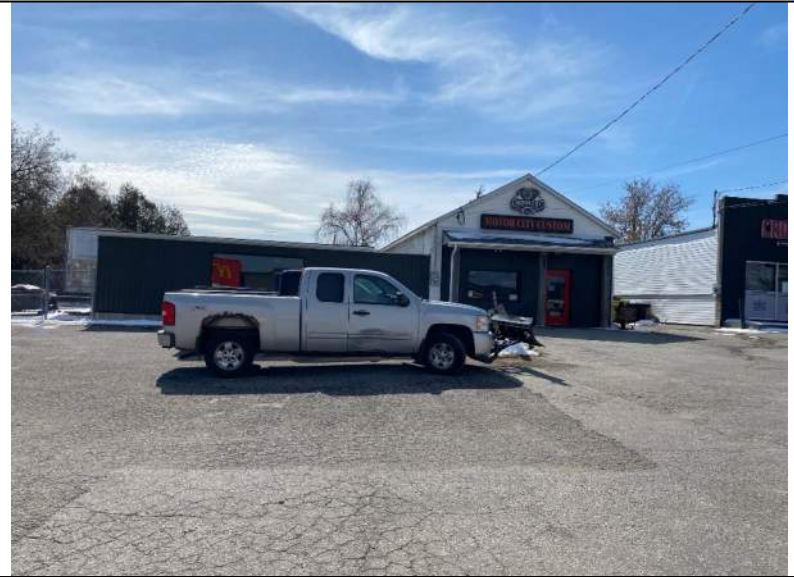
Photograph 10:
View looking south at vehicle repair garage at 287 Dean Ave.

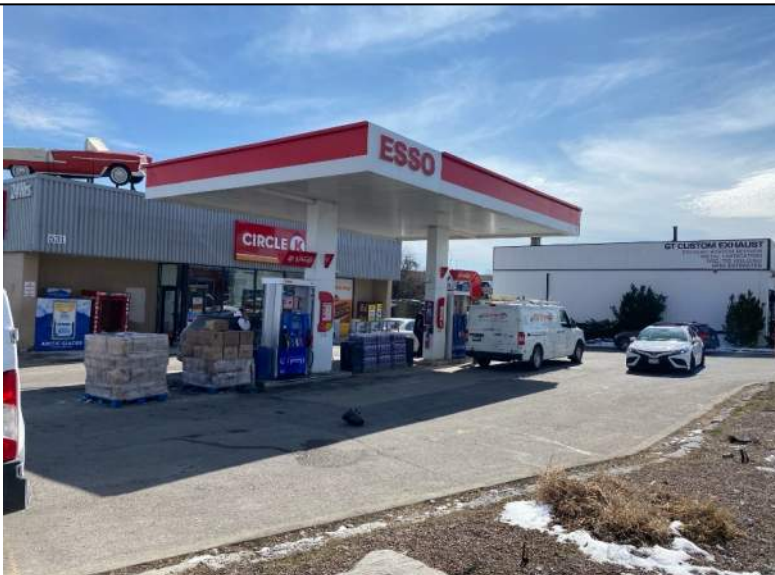
Photograph 11:
View looking southeast at retail fuel outlet at 531 Ritson Road S..

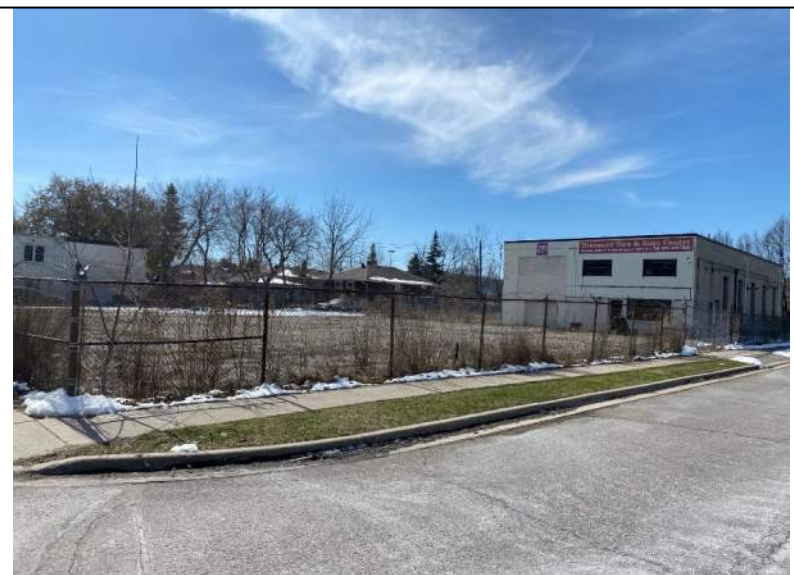
Photograph 12:
View looking west at 396 Drew Street, waste tires visible and signage indicating historical use as a vehicle repair garage.

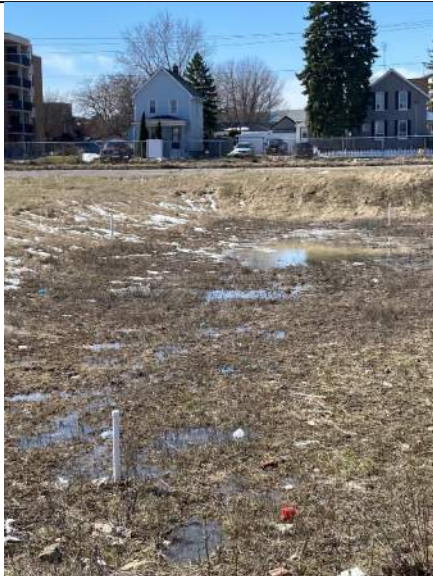
Photograph 13:

View looking west at 63 Albany Street, monitoring wells visible. Former metal foundry use, RSC completed in 2017.

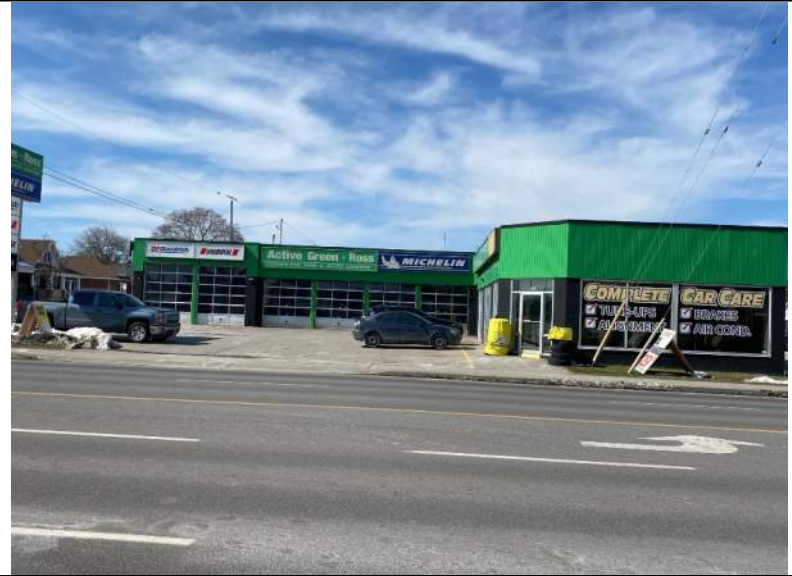
Photograph 14:

View looking west at 534 Ritson Road S., an active vehicle repair garage.

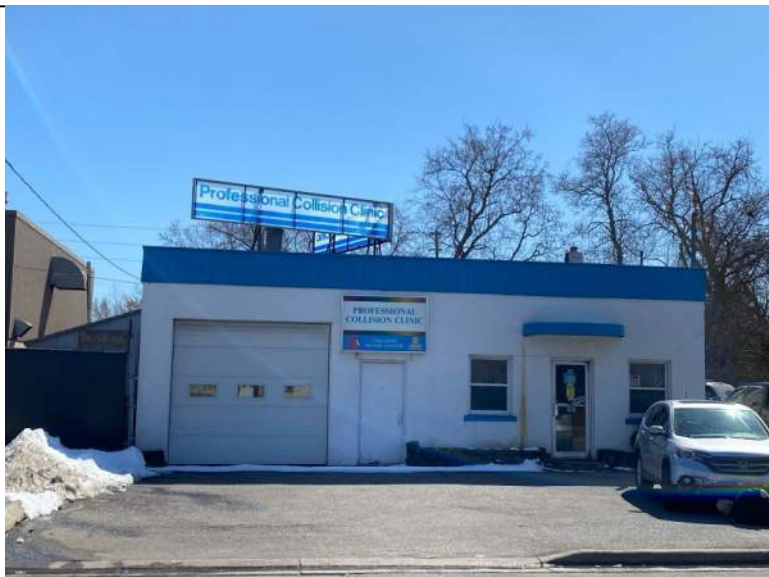
Photograph 15:

View looking south at 227 Toronto Avenue, an active vehicle repair shop.

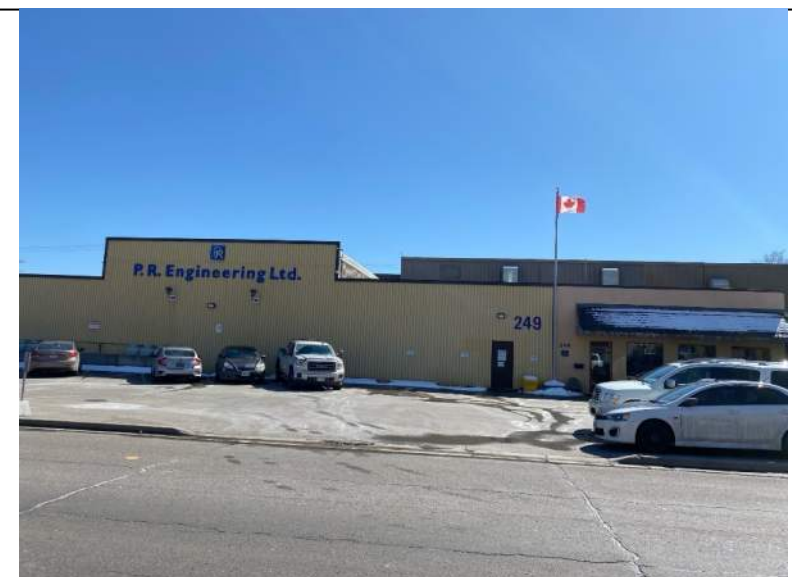
Photograph 16:

View looking south at 249 Toronto Avenue, P.R. Engineering listed as a metal product manufacturer since 1965.
